Shem Dam Rehabilitation Project Overview

Shem Dam

A Photographic Timeline of Construction and Repairs

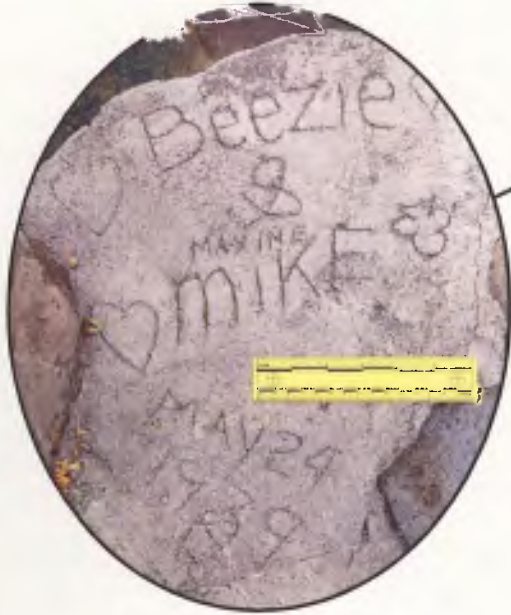
1938:

March 2, 1938 flood damaged the dam and the CCC repaired the crest, abutment and wingwalls.

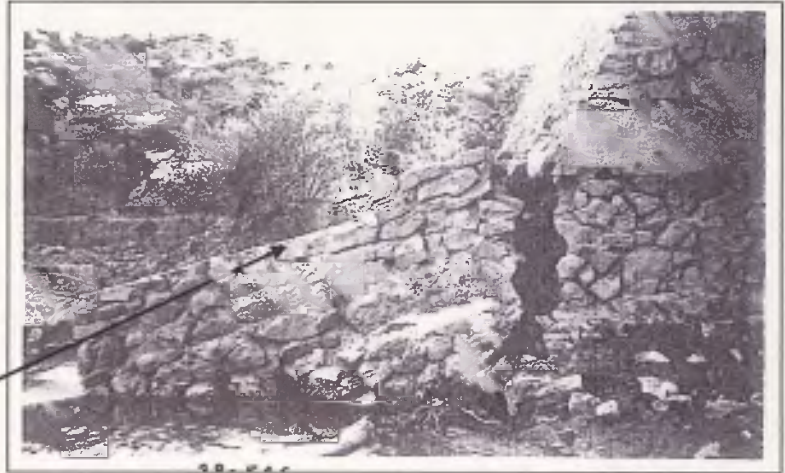
Damages from March 1938 flood showing western wingwall. The names of two CCC workers are etched into the concrete.

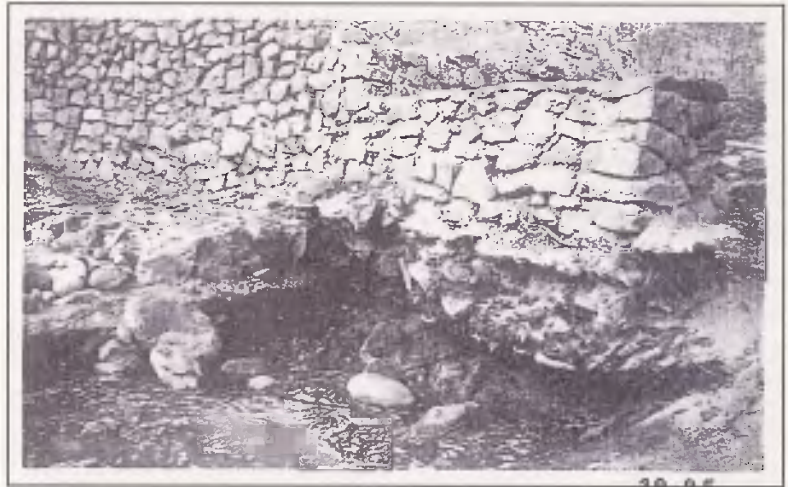
Damages from March 1938 flood showing eastern wingwall.

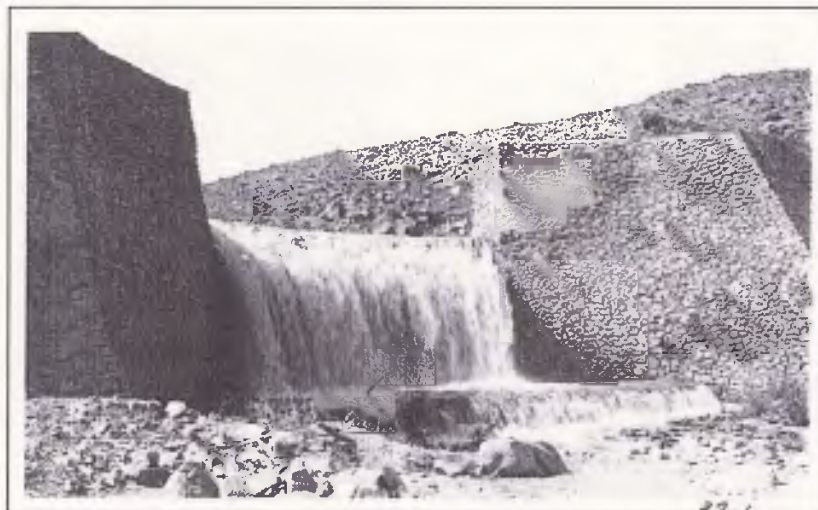
1941:

Large amount of silt deposited upstream from dam during high water event. Photo below taken during 1937 high water.

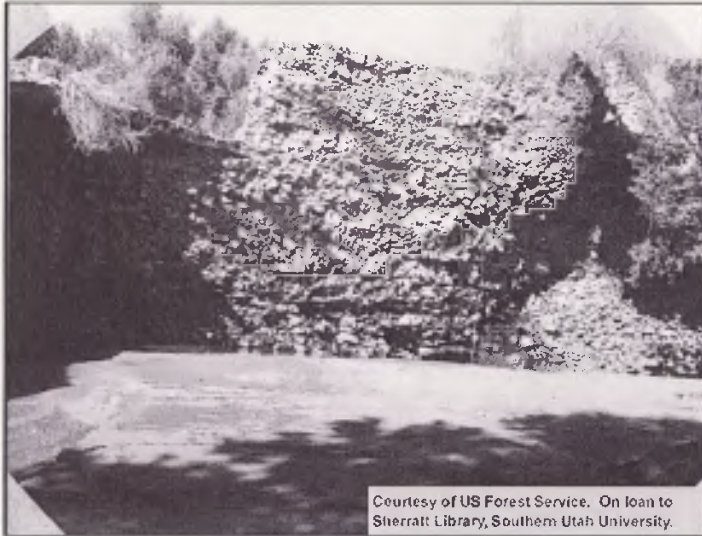
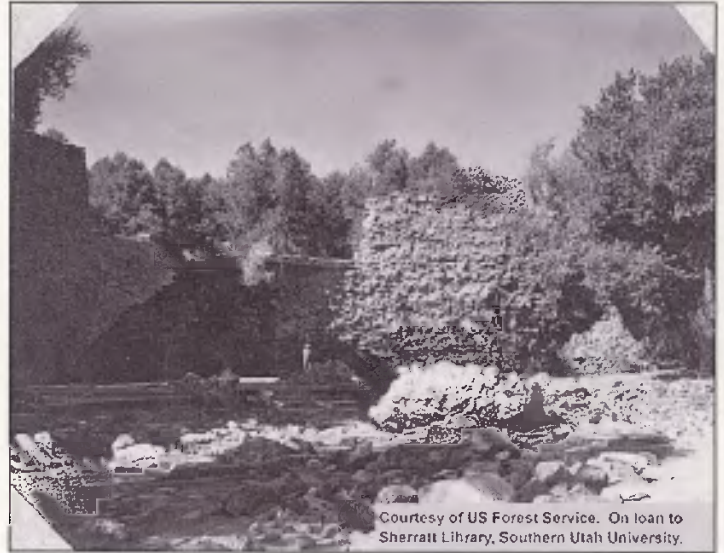
1955:

Flood destroyed downstream side of crest, leaving a hollow shell. The eastern abutment was also damaged.

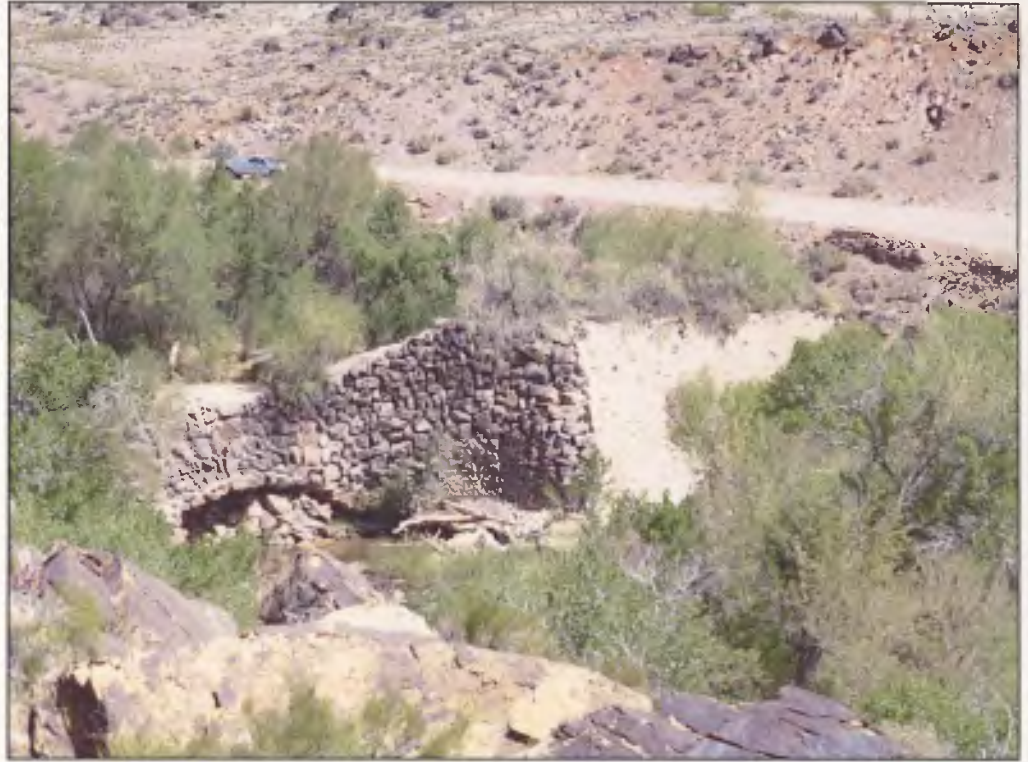
2013:

Much of the dam's current structural issues can be attributed to the lack of a solid foundation. When the CCC built the dam in 1933, they did not have a water pump powerful enough to remove water from the channel to excavate the foundation. Therefore, most of the dam is sitting on top of sand and gravel. When water flows over the dam, it undercuts the crest and undermines the structural stability.

Without a solid foundation, the downstream side of the crest is collapsing from underneath. There is virtually no mortar left in between the basalt boulders on the eastern abutment repaired in 1958. Water is also seeping through the eastern side of the crest. Without repair, the dam will likely fail.

The main goal of the dam rehabilitation is to stabilize the structure so it does not fail. To accomplish this, the NRCS is proposing to build a masonry bench along the downstream side of the crest and abutments. A concrete chute or slide will protrude from the front of the crest to keep water away from the base, and avoid further undercutting. Trees and vegetation that are growing within and around the dam will also need to be removed as they are comprising its stability.
