Report Number 05-03

**Historic Context and Detailed Documentation of the Main Canyon
Ditch, Town Ditch, Comanche Dam (42WS4376), and Comanche
Ditch (42WS2507), New Harmony, Washington County, Utah**

August 2005

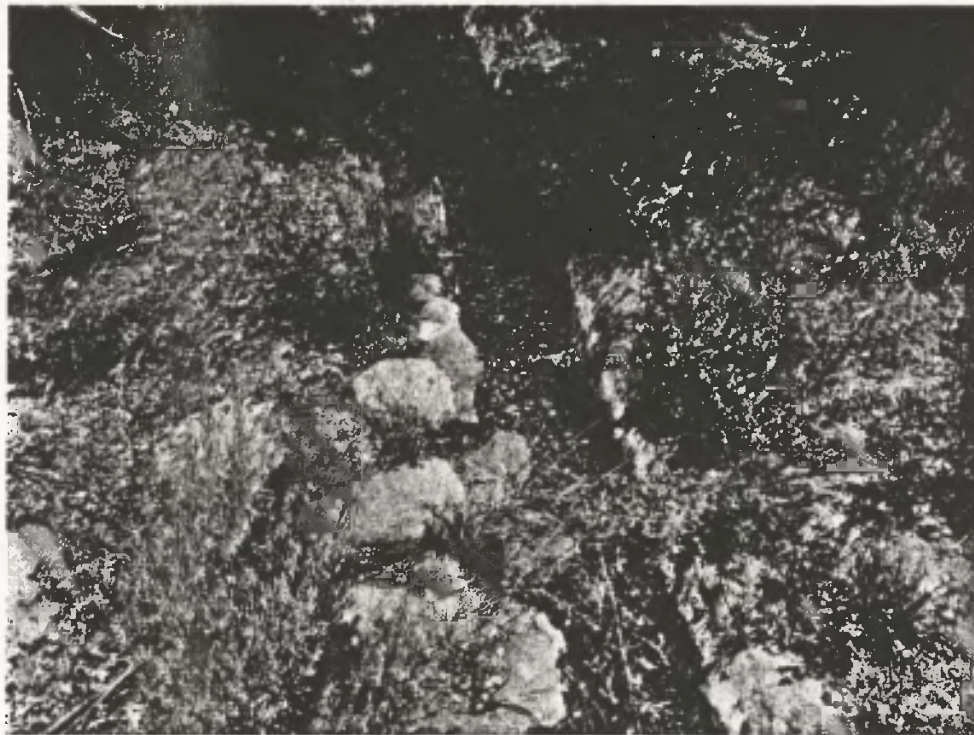
Figure 3. Comanche Ditch (42WS2507)

The Work Projects Administration (WPA) constructed the Comanche Ditch most likely in 1935 / 1936 to bring water from Comanche Spring, located along the eastern foothills of the Pine Valley Mountains, to the Town of New Harmony. The ditch originates at Comanche Spring within T 38S, R 13W, Section 17 on land administered by the U.S. Forest Service – Dixie National Forest at an elevation of approximately 5790 ft. From this point the ditch proceeds southeast onto the proposed project area within T 38S, R 13W, Section 21 to an elevation of about 5379 ft. where it joins the Town Ditch. A total length for the ditch is roughly 2350 m (1.46 mile). The ditch is not depicted on the New Harmony 7.5' topographic quadrangle map dated 1986 and was not indicated on GLO maps of the area, however it is visible on aerial photos (Figure 4).

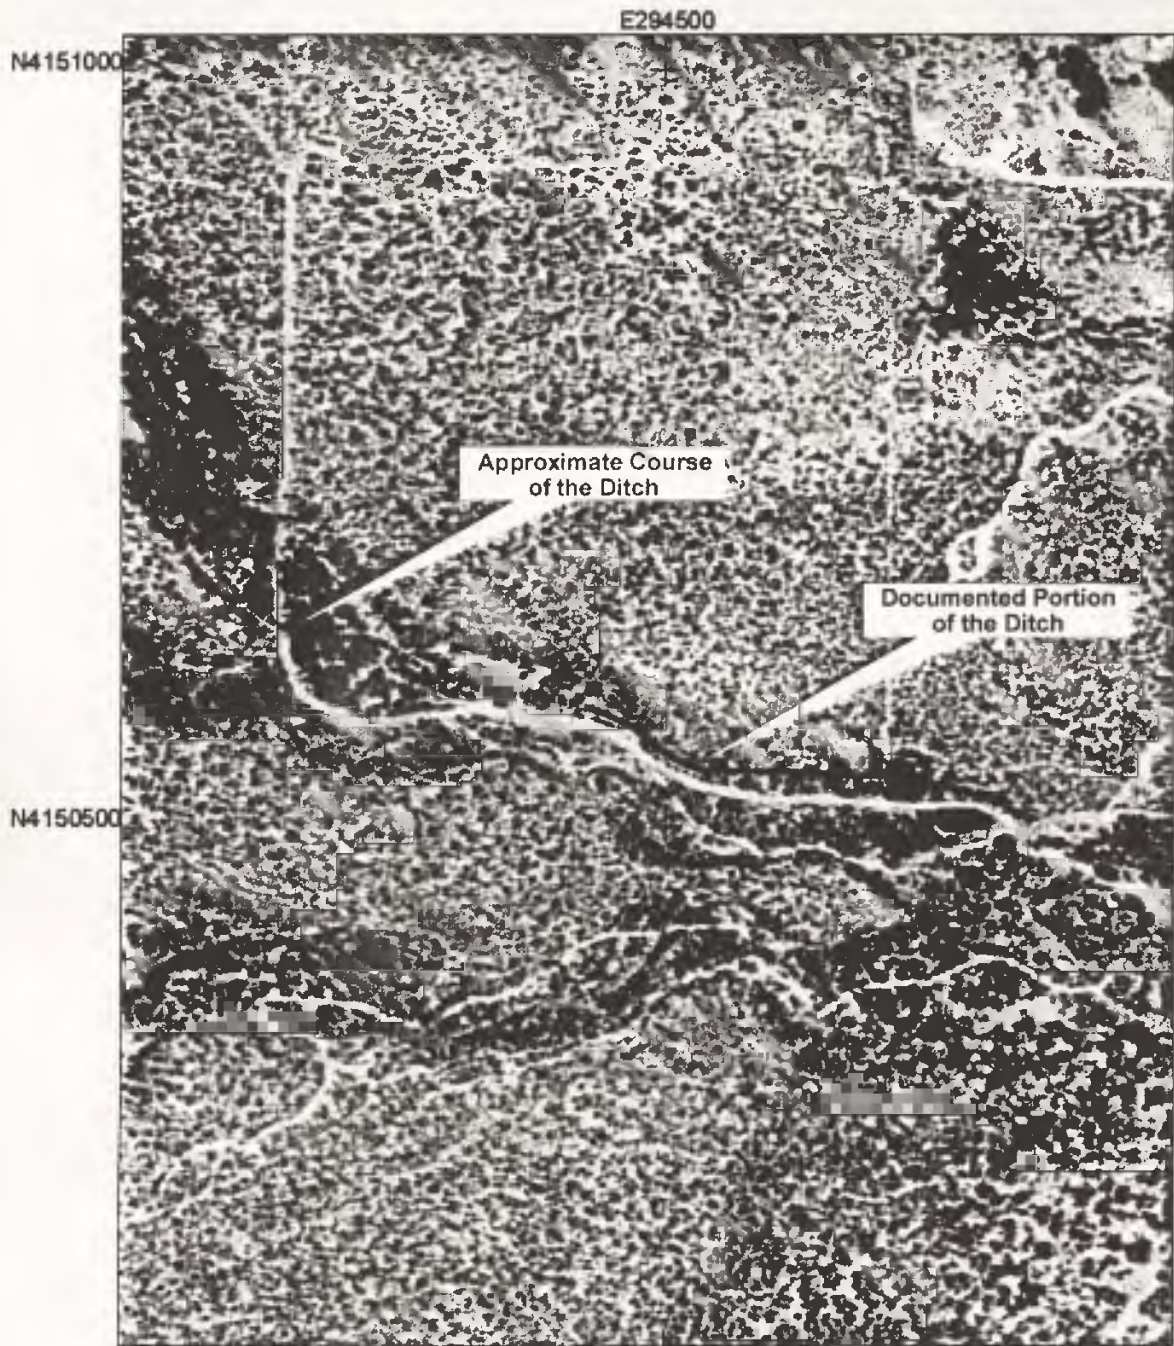
**Figure 4. Aerial Photograph of the Comanche Ditch (42WS2507). USGS
7.5' Digital Orthophoto Quadrangle: New Harmony, Utah 5/10/1997**
