Report Number 05-03

**Historic Context and Detailed Documentation of the Main Canyon
Ditch, Town Ditch, Comanche Dam (42WS4376), and Comanche
Ditch (42WS2507), New Harmony, Washington County, Utah**

August 2005

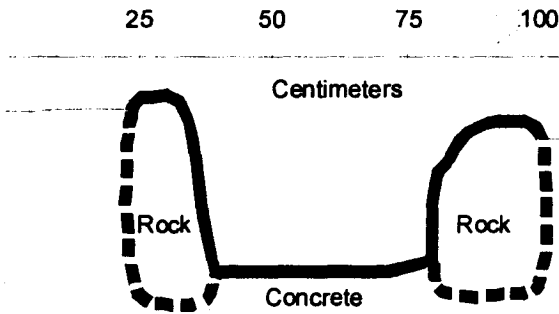
Figure 5. Cross-section of the Comanche Ditch (42WS2507)

Examination of this ditch included 302 m (991 ft.) from its junction with the Town Ditch and extended west (Figures 1 & 2). The ditch near its junction with the Town Ditch is concrete lined with a “V” or “U” shaped profile (Figure 6, Appendix A). This section is about 11.75 m (38.55 ft.) long. Beyond this, to the west, the ditch has a flat concrete bottom with shaped stone sides that have been cemented together (Figures 3 & d 5; Appendix A). Most of the ditch, approximately 1800 m (1.12 mile), lies within the Dixie National Forest and has been documented and reported by Marion Jacklin and Gina Pack (1989). They indicate the presence of several metal culvert features. The ditch is in fairly good condition and continues to transport water into the Town Ditch, although a diversion has been installed not

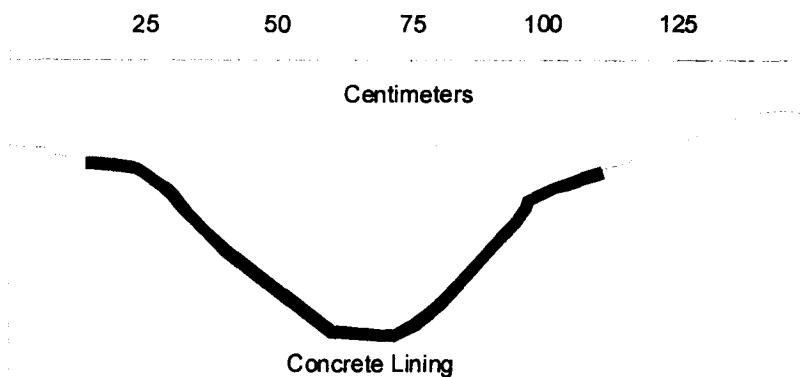
Figure 6. Cross-section of the Comanche Ditch (42WS2507) near its joining with the Town Ditch (42WS4376)

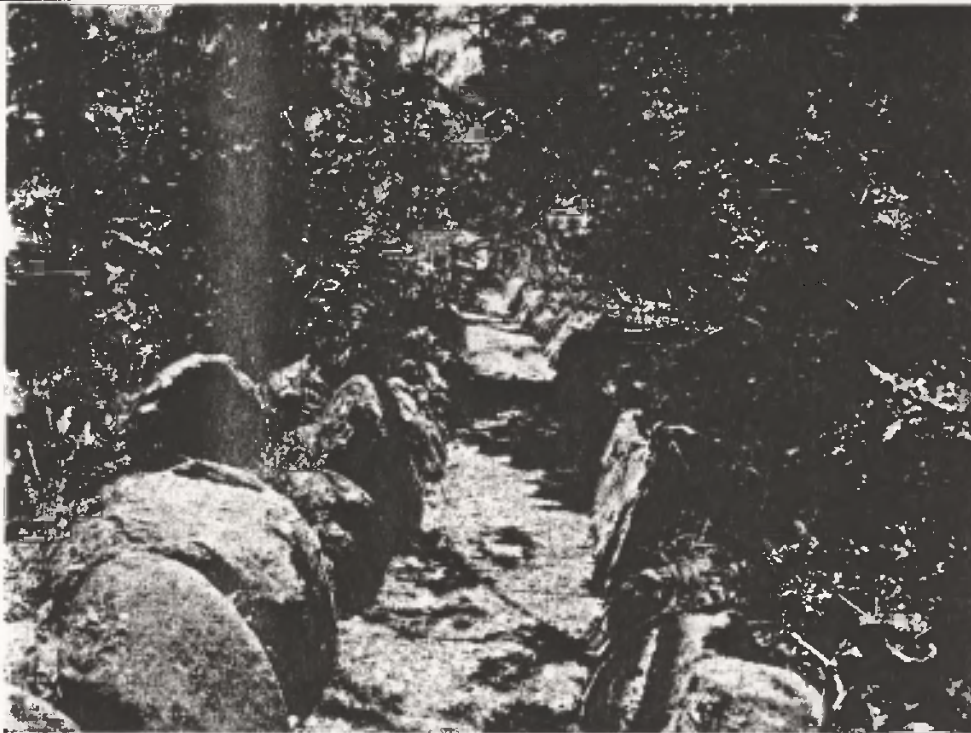
Figure 7. Main Canyon Ditch (42WS4376) with large rocks along its sides

The Main Canyon ditch was also constructed by the WPA around 1935 / 1936. This ditch was constructed prior to the Comanche Ditch, as indicated by personal interviews with local informants (see below), to bring water from the Pine Valley Mountains to the Town of New Harmony. An origination point for the ditch is up Main Canyon, however its exact origin is not known and it is not depicted on topographic / GLO maps of the area. The ditch is visible on aerial photographs of the area and is indicated in Figure 9.

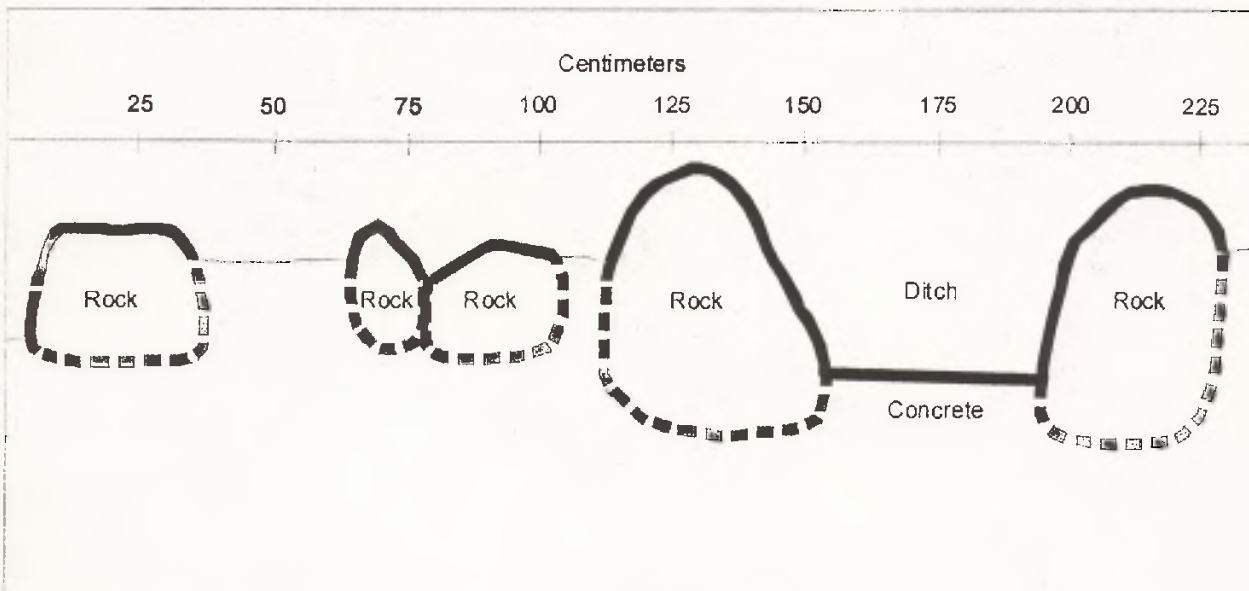
Figure 8. Cross-section of the Main Canyon Ditch (42WS4376)
