**BIGHORN ARCHAEOLOGICAL
CONSULTANTS, LLC**

Report Number 05-03

**Historic Context and Detailed Documentation of the Main Canyon
Ditch, Town Ditch, Comanche Dam (42WS4376), and Comanche
Ditch (42WS2507), New Harmony, Washington County, Utah**

August 2005

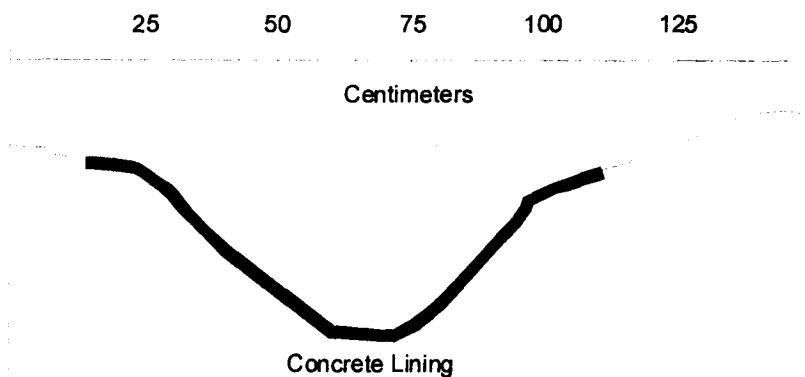
Figure 6. Cross-section of the Comanche Ditch (42WS2507) near its joining with the Town Ditch (42WS4376)

Examination of this ditch included 302 m (991 ft.) from its junction with the Town Ditch and extended west (Figures 1 & 2). The ditch near its junction with the Town Ditch is concrete lined with a “V” or “U” shaped profile (Figure 6, Appendix A). This section is about 11.75 m (38.55 ft.) long. Beyond this, to the west, the ditch has a flat concrete bottom with shaped stone sides that have been cemented together (Figures 3 & d 5; Appendix A). Most of the ditch, approximately 1800 m (1.12 mile), lies within the Dixie National Forest and has been documented and reported by Marion Jacklin and Gina Pack (1989). They indicate the presence of several metal culvert features. The ditch is in fairly good condition and continues to transport water into the Town Ditch, although a diversion has been installed not

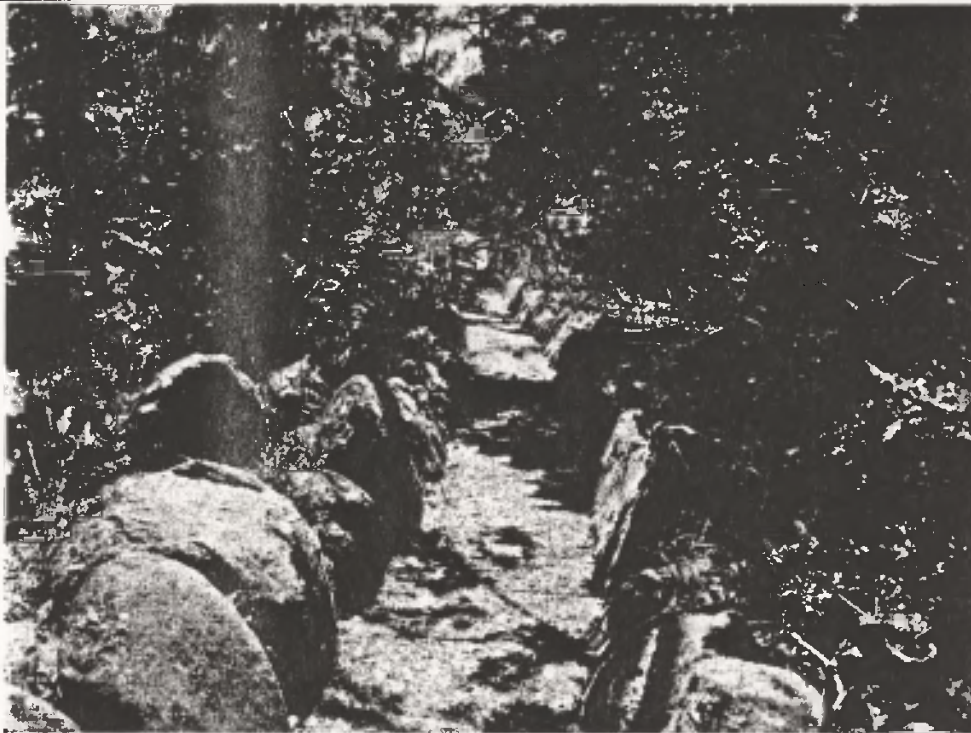
Figure 7. Main Canyon Ditch (42WS4376) with large rocks along its sides

The Main Canyon ditch was also constructed by the WPA around 1935 / 1936. This ditch was constructed prior to the Comanche Ditch, as indicated by personal interviews with local informants (see below), to bring water from the Pine Valley Mountains to the Town of New Harmony. An origination point for the ditch is up Main Canyon, however its exact origin is not known and it is not depicted on topographic / GLO maps of the area. The ditch is visible on aerial photographs of the area and is indicated in Figure 9.
